---TECHNICAL REPORT---

No. 13755

Test and Evaluation of the
LMTV Driveline
1998

By Stephen J. Aamodt

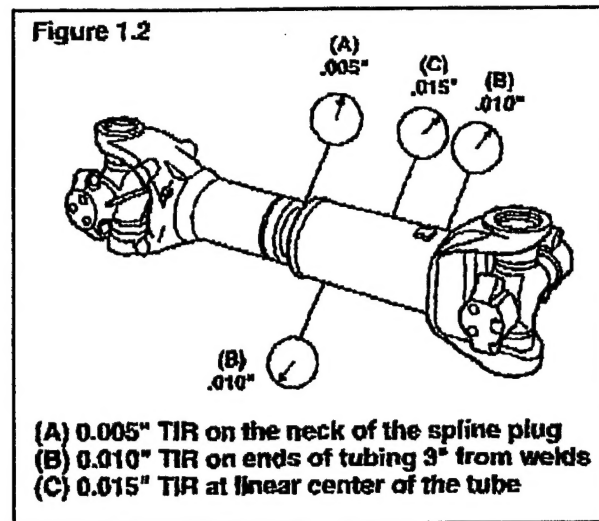
Figure 1 - Driveshaft Runout Specifications

When checking with the PM's office regarding this finding, it was revealed that the shaft did meet the specifications for balance as provided by the manufacturer, Meritor, but did not meet the specification for runout. The Meritor specifications stated for balance that a value of 2.06 inch-ounces is the maximum on the slip end and 1.49 inch-ounces is the maximum on the weld yoke end. Runout values that should not be exceeded are 0.005 inches on the spline plug, 0.015 inches in the center and 0.010 inches on the weld side. Refer to figure 1 for the visual locations of these values as specified by the manufacturer.

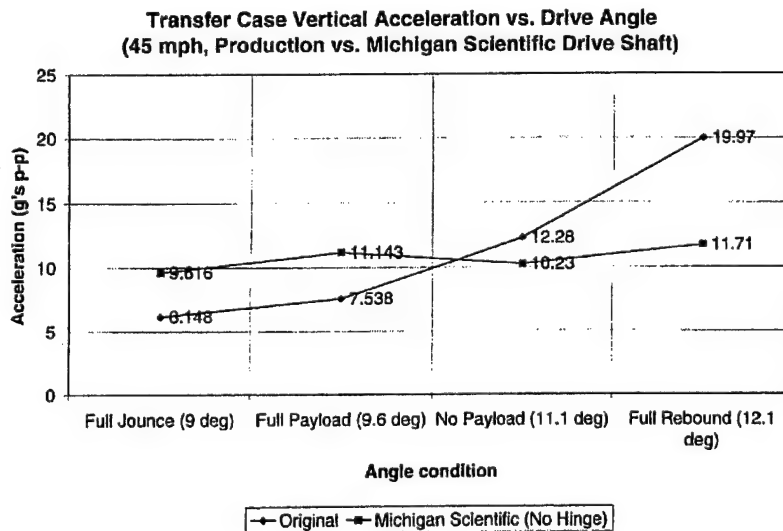
Figure 11 - Comparison of Vertical Accelerations in Resonant Range

The data for both the MSC driveshaft and the production driveshaft indicated marked increase in acceleration levels as the driveline angle increased. The MSC driveshaft, with the elimination of the hinging effect, proved more effective than the production driveshaft with nylon thrust washers in the resonant frequency range at the high angles. Outside of the resonant range and high angles, no particular driveshaft had an advantage all the time. Figure 11 shows a visual representation of the performance of these two shafts within a resonant frequency range measuring g-loads from peak to peak.

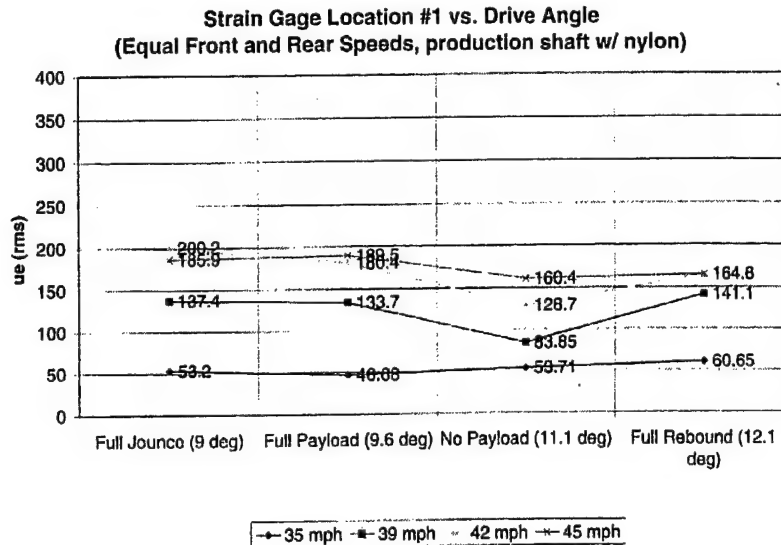
Figure 12 - Production Flywheel Housing strain versus speed and angle

The flywheel housing strain, measured at strain gauge one, does not appear to be effected by drivetrain angle. What does affect the flywheel housing strain appears to be the speed at which the vehicle is moving. From figure 12, it is visible that this type of relationship exists.

Reduced speed then is the key issue behind keeping the strain levels down on the flywheel housing while a reduced driveline angle is the key to keeping the accelerations down at the transfer case universal joint.
